# CAFO FACILITY INSPECTION REPORT

<u>8335630001</u> WDID NUMBER	<u>Andy Dyt</u> OWNER NAME	<u>Dyt Dairy No. 1</u> FACILITY NAME
<u>CAG018001</u> NPDES NUMBER	<b>Ex. 6 Personal Privacy (PP)</b>	
<u>R8-2007-0001</u> RWQCB ORDER NO.	<u>Corona, CA 91720</u> OWNER CITY AND STATE	<u>Corona, CA 91720</u> FACILITY CITY AND STATE
<u>04/09/2013</u> SCHEDULED INSPECTION DATE	<u>Andy Dyt</u> OWNER CONTACT	<u>Andy Dyt</u> FACILITY CONTACT
<u>04/09/2013</u> ACTUAL INSPECTION DATE	<b>Ex. 6 Personal Privacy (PP)</b>	
<u>Cucamonga Channel</u> RECEIVING WATER	<u>Ex. 6 Personal Privacy (PP)</u>	
	FACILITY LATITUDE	FACILITY LONGITUDE

REPORT PREPARED BY: Anthony D'Angelo (PG Environmental, LLC) ON 04/19/2013

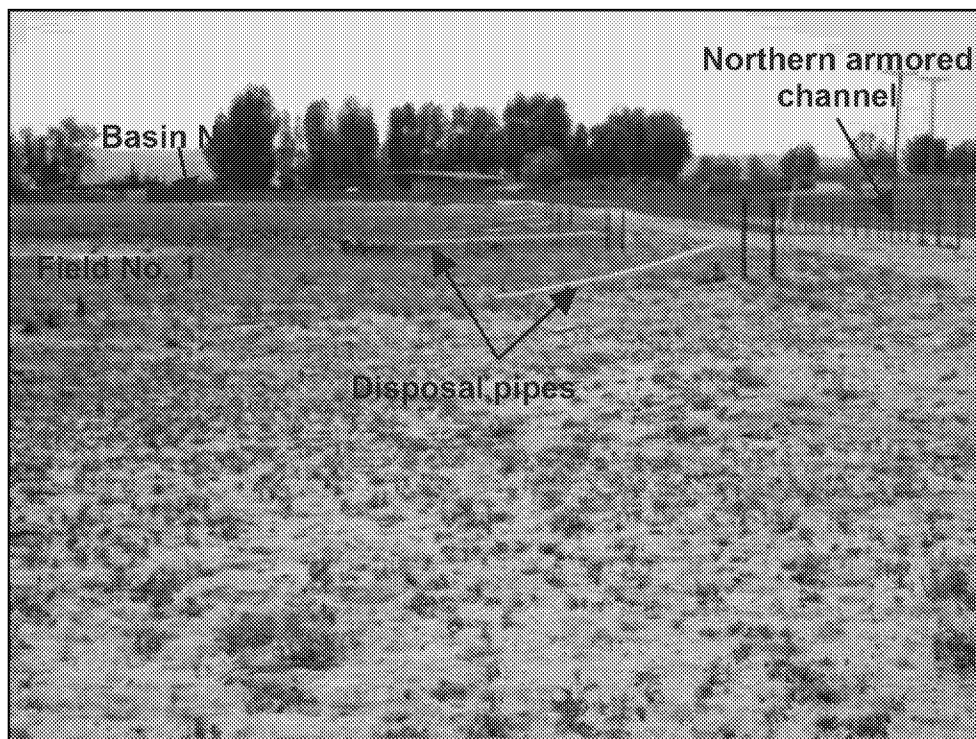
**Photograph 2.** View facing west of the process wastewater disposal pipes located along the northern portion of field No. 1.

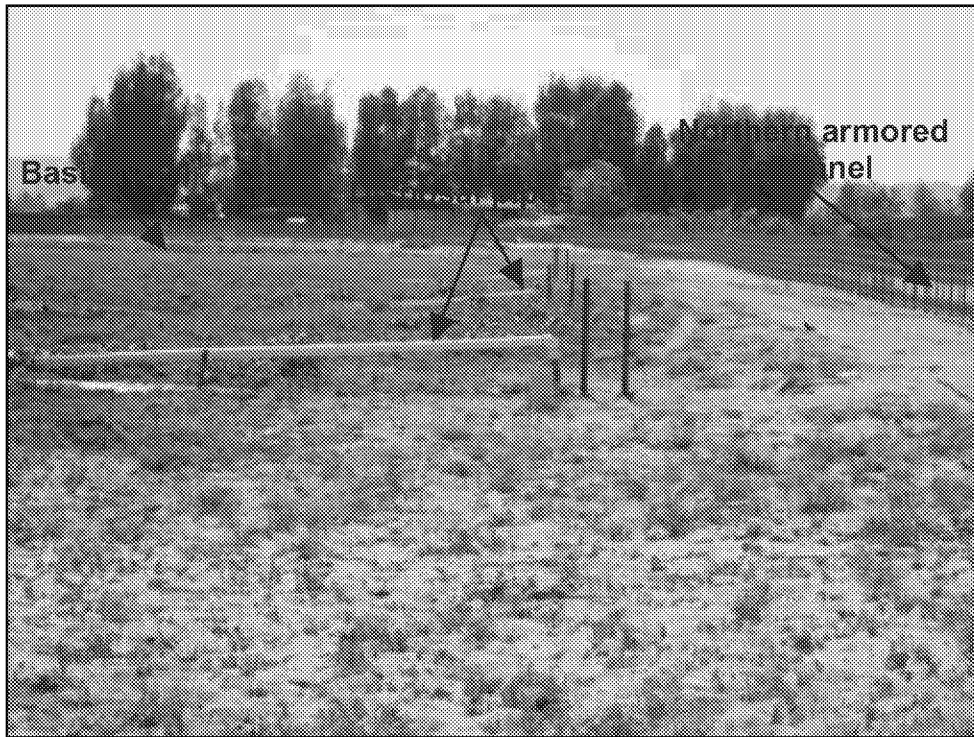
**Photograph 3.** Additional view facing west of the process wastewater disposal pipes located along the northern portion of field No. 1, shown in Photograph 2.

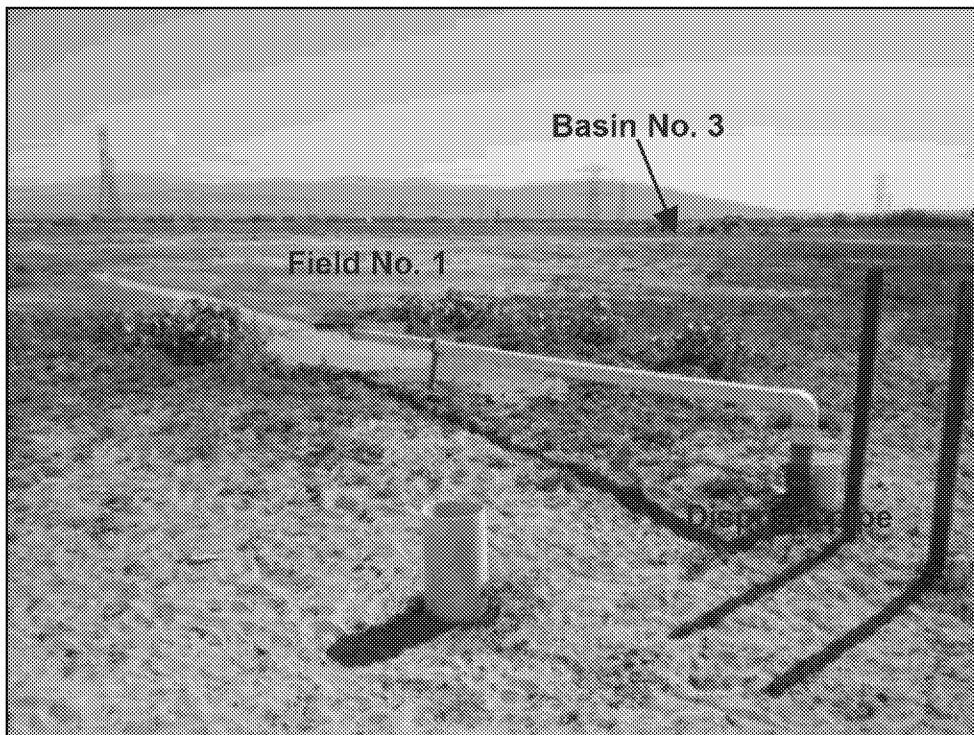
**Photograph 4.** Close-up view of a process wastewater disposal pipe shown in Photographs 2 and 3.

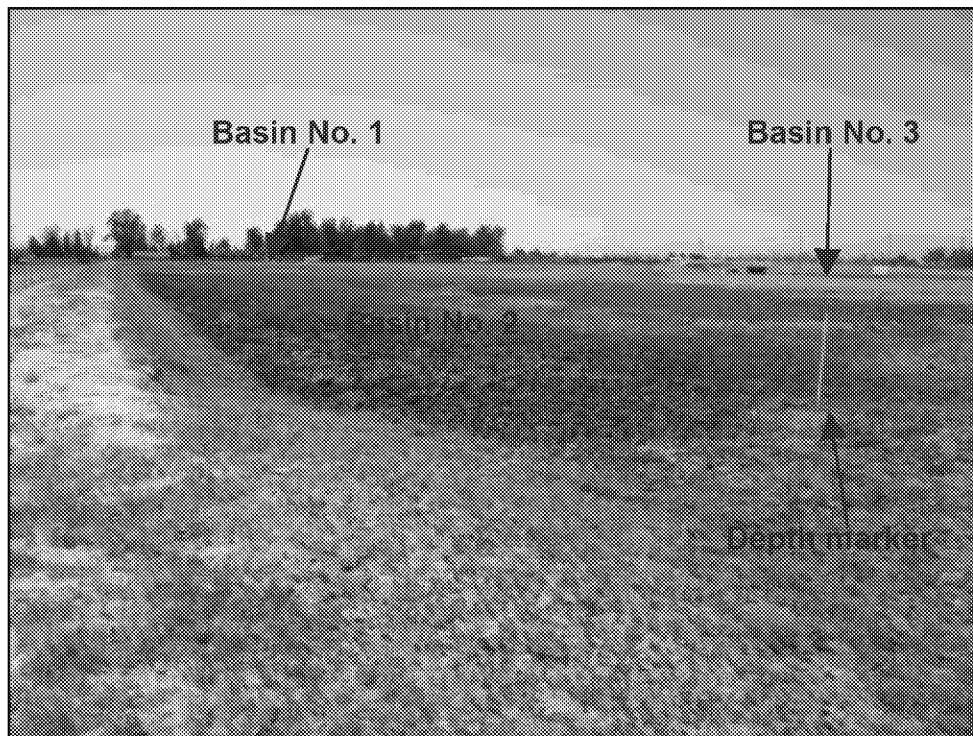
2. The inspector observed, during the inspection, that the depth marker installed in basin No. 2 did not have depth measurement markings to clearly identify basin depth and an estimate of freeboard (refer to Photos 6, 7, and 8). Permit Attachment B - Monitoring and Reporting Program, Section I.B.1 states that "a marker shall be placed within each pond or impoundment to indicate the minimum capacity necessary to contain the runoff and direct precipitation of the 25-year, 24-hour rainfall event."

**Photograph 6.** View facing west of basin No. 2 located along the southern perimeter in the western portion of the Facility. Note the basin receives storm water runoff from central and southern corrals. Also note the depth marker did not contain depth markings to estimate freeboard.

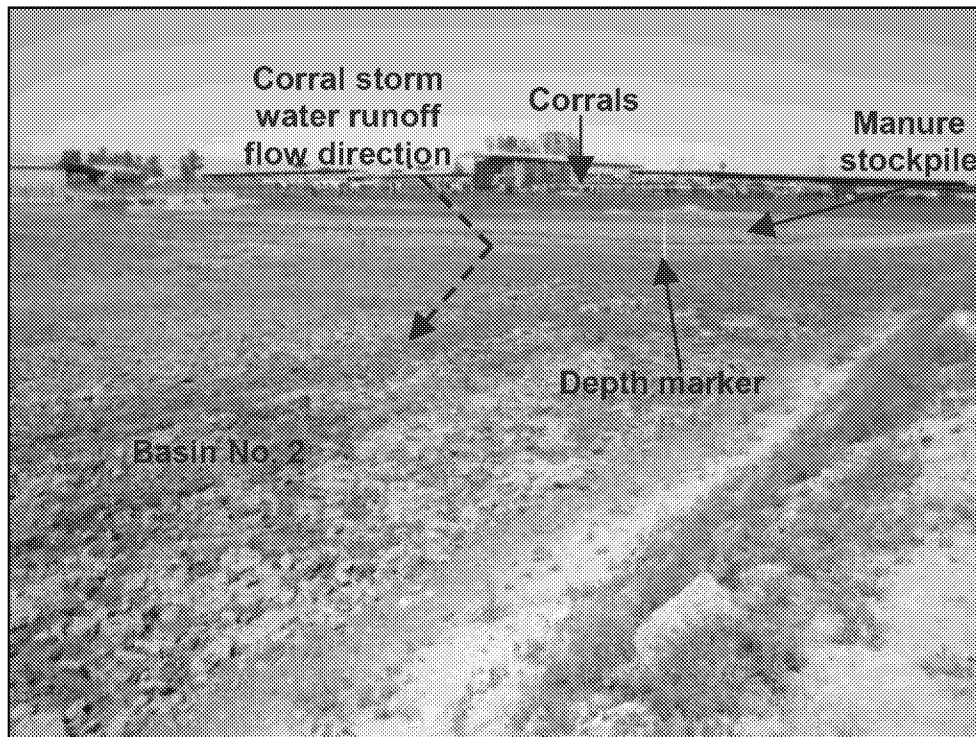
**Photograph 7.** View facing northeast of basin No. 2. Note the basin collects storm water runoff from the central and southern corrals east of the basin.

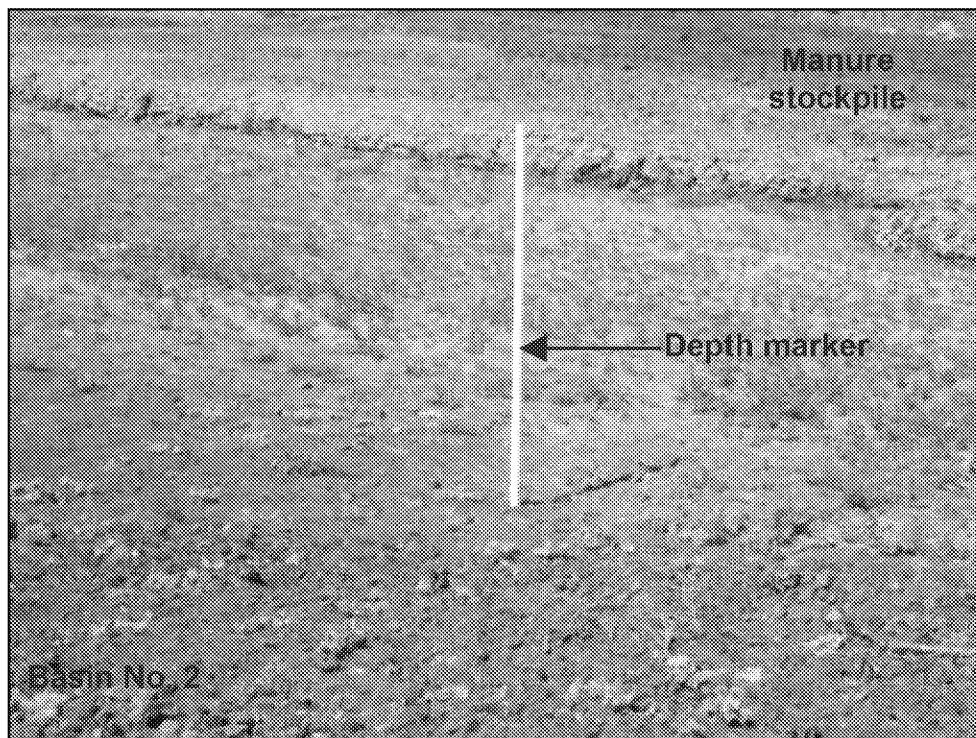
**Photograph 8.** Close-up view of the depth marker on the east side of basin No. 2, shown in Photographs 6 and 7. Note the depth marker did not contain depth measurement markings to adequately estimate freeboard. This was the only depth marker at the Facility.

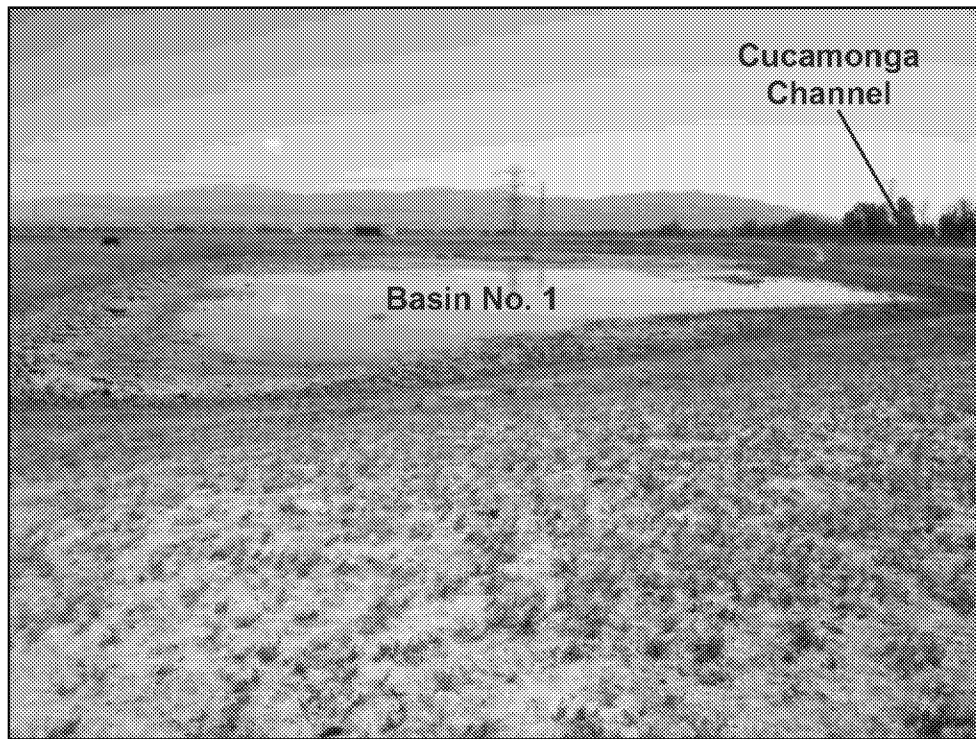
1. Depth markers were not installed in basin Nos. 1 and 3 as required by Permit Attachment B - Monitoring and Reporting Program, Section I.B.1 (refer to Photos 5 and 9).

1. The inspector observed, during the inspection, that depth markers had not been not installed in basin Nos. 1 and 3 located in the western portion of the Facility as required by the Permit (refer to Photos 5 and 9). Mr. Dyt stated that the Santa Ana Water Board had previously given him approval to only install and maintain a depth marker in basin No. 2. It should be noted that basin No. 1 contained the Facility emergency concrete spillway; however, did not contain a depth marker (refer to Photos 9 through 12). Permit Attachment B - Monitoring and Reporting Program, Section I.B.1 states that "a marker shall be placed within each pond or impoundment to indicate the minimum capacity necessary to contain the runoff and direct precipitation of the 25-year, 24-hour rainfall event."

**Photograph 9.** View facing south of basin No. 1. Note the basin did not contain a depth marker.

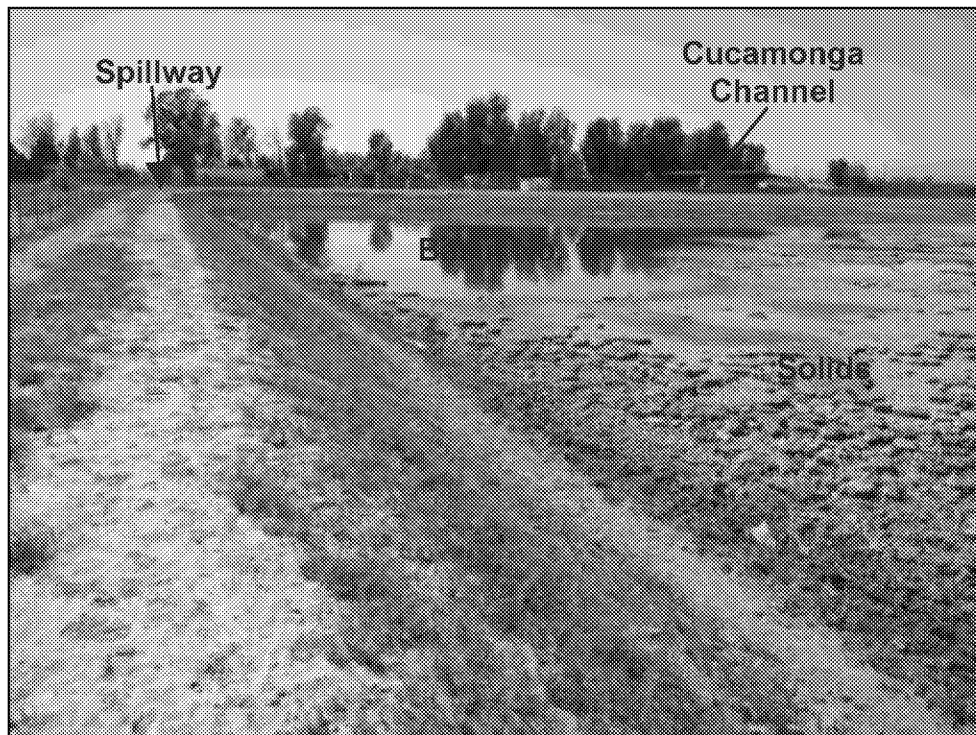
**Photograph 10.** View facing west of the southwest corner of basin No. 1. Note a concrete spillway was present in the southwest corner of the basin, adjacent to Cucamonga Channel.

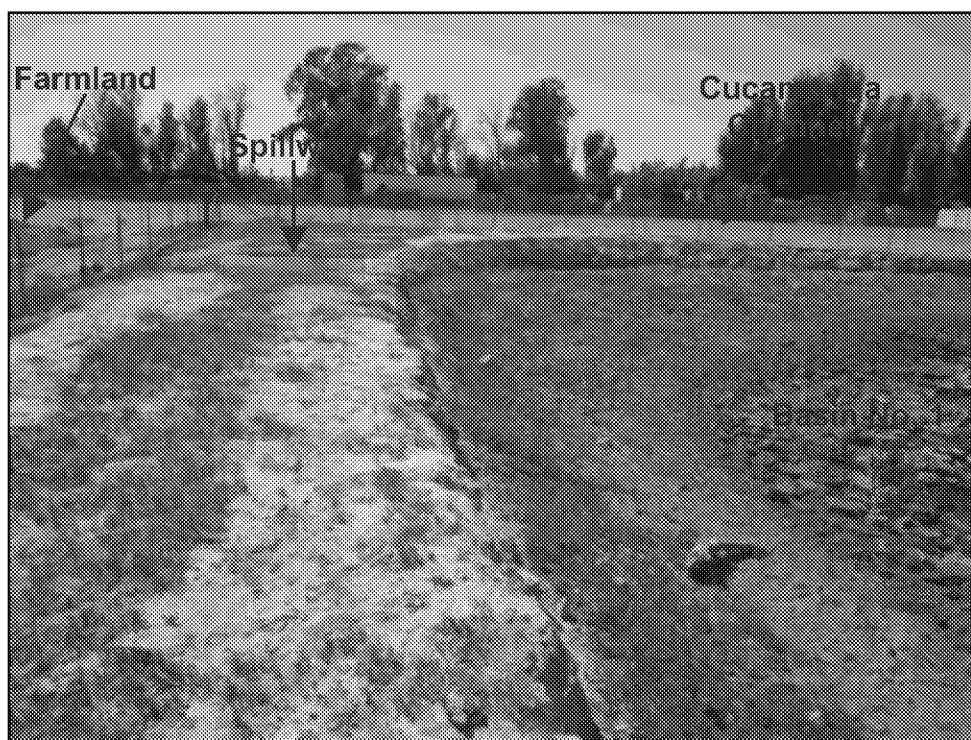
**Photograph 11.** View facing west of the concrete spillway located in the southwest corner of basin No. 1. Note the concrete spillway drains into an adjacent farmland to the south and subsequently into Cucamonga Channel located along the western perimeter of the Facility.

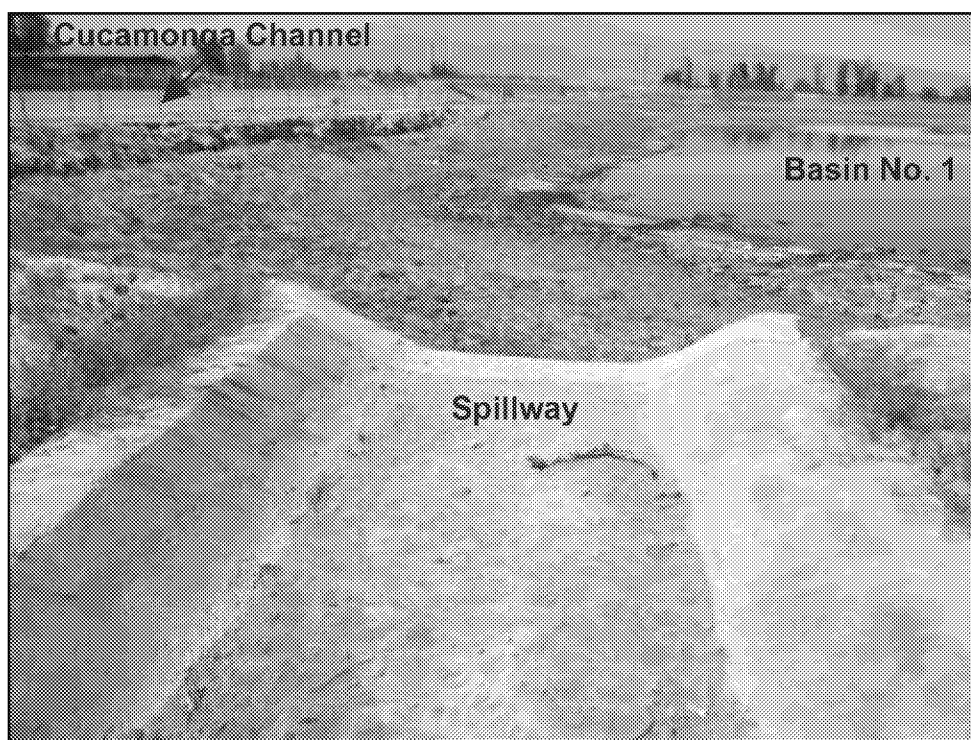
**Photograph 12.** View facing north from the Facility concrete spillway in the southwest corner of basin No. 1.

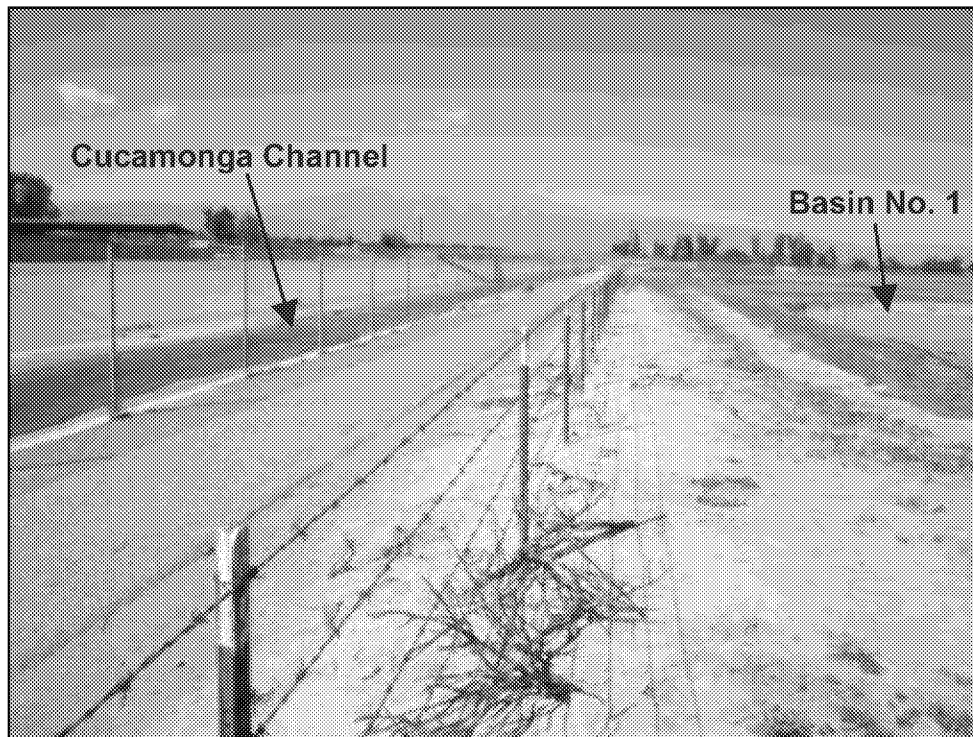
**Photograph 13.** View facing north along the western Facility perimeter of basin No. 1 and the Cucamonga Channel.

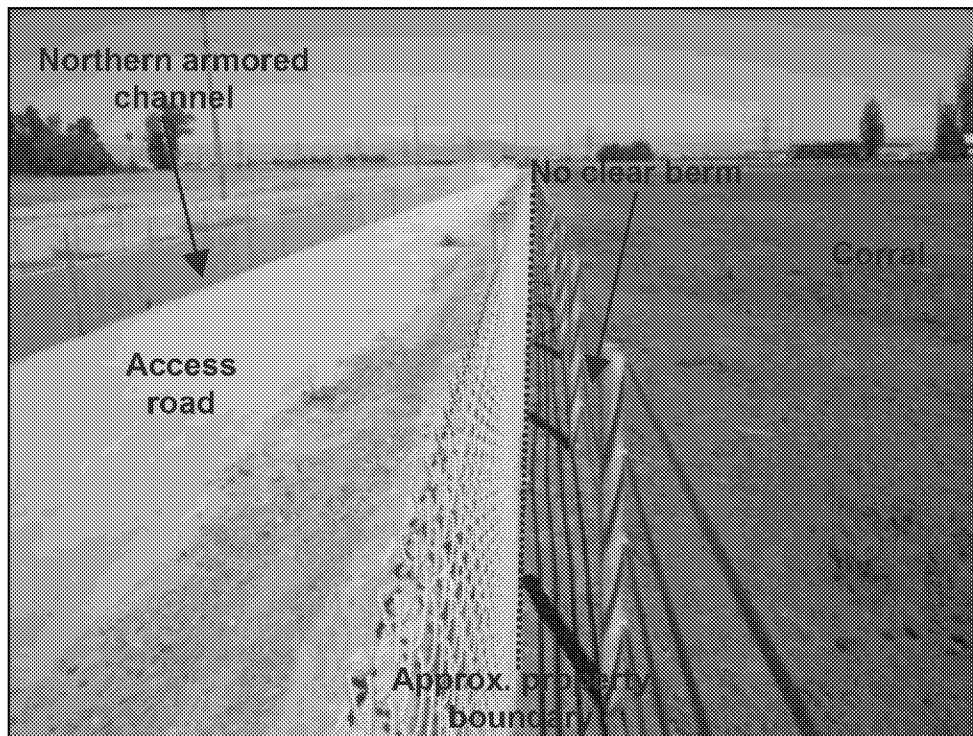
4. A release of manure offsite to a flood control access road was observed along the northern Facility perimeter (refer to Photos 14 and 15). In addition, a berm had not been constructed along the northern Facility perimeter in accordance with the EWMP Site Plan. Discharge Prohibition IV.B of the Permit states that a "disposal of manure to land is prohibited."

1. The EWMP was not fully implemented onsite at the Facility as required by the Permit. Construction Note No. 2 of the EWMP Site Plan identifies that a berm will be constructed along the northern perimeter of the Facility, adjacent to the northern armored flood control channel, in accordance with Section "B"- "B" of the EWMP Site Plan. The inspector observed, during the inspection, that an earthen berm along the northern portion of the northern corrals was not constructed per the EWMP Site Plan Section "B"- "B" (refer to Photos 14 and 15). As a result, the Discharger was not fully implementing the approved EWMP. Provision VII.C.3.b of the Permit states that "the discharger shall develop and fully implement an Engineered Waste Management Plan (EWMP) acceptable to the Executive Officer." The Discharger shall fully implement the EWMP as required by Provision VII.C.3.b of the Permit.

1. The inspector observed, during the inspection, evidence of a previous release of manure offsite to the north from the northwestern cow corral onto an offsite armored flood control channel access road (refer to Photos 14 and 15). Construction Note No. 2 of the EWMP Site Plan identifies that a berm shall be constructed per Section "B"- "B" along the northern perimeter of the Facility, adjacent to an offsite armored flood control channel. A berm was not installed along the northern perimeter of the northern corrals, resulting in a release of manure offsite onto the armored flood control channel access road which subsequently flows to Cucamonga Channel. As a result, manure was released offsite to the north. Discharge Prohibition IV.B of the Permit states that a "disposal of manure to land is prohibited."

**Photograph 14.** View facing northeast of the northern Facility perimeter between the northern corrals and an unnamed armored channel. Note a previous release of manure from the corral offsite to the armored channel access road. Also note a berm had not been constructed along the northern perimeter of the corral per Section "B"- "B" of the EWMP Site Plan.

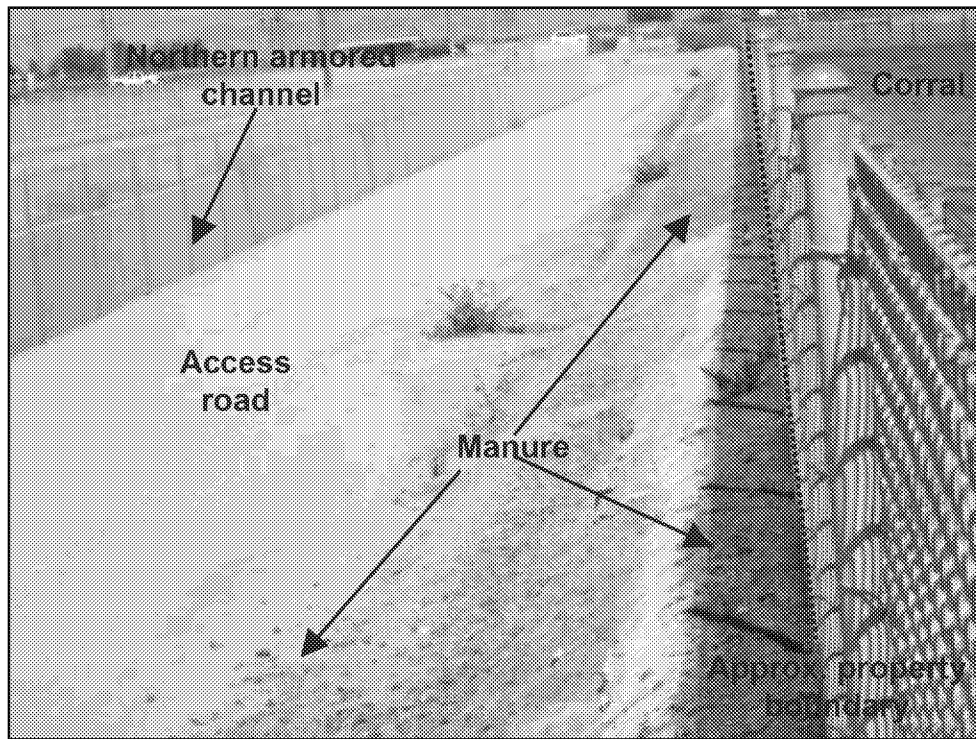
**Photograph 15.** View facing northeast of manure previously released offsite to the north from the northern corrals onto the adjacent armored channel access road.

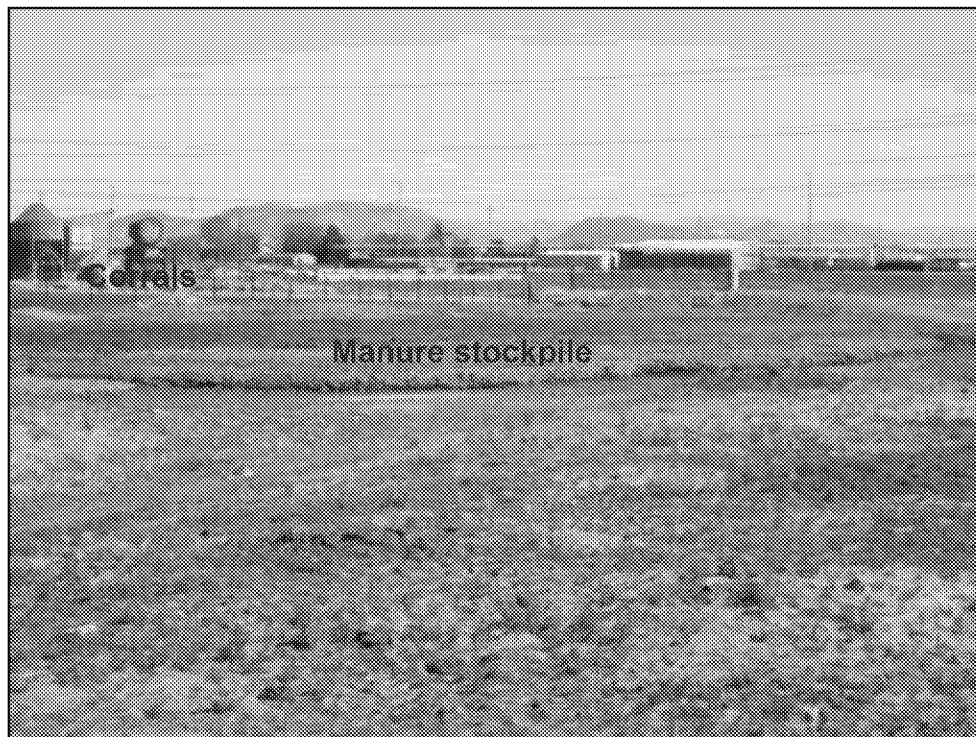
**Photograph 16.** View facing east of a manure drying stockpile located on the west side of the southern corrals.

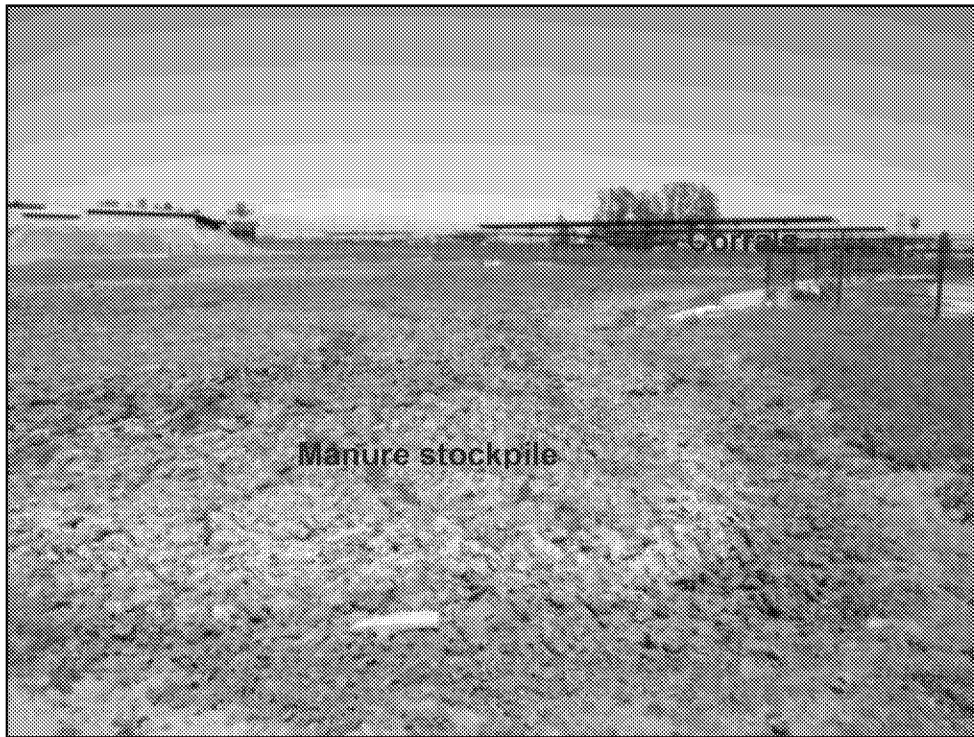
**Photograph 17.** View facing east of a manure drying stockpile located on the west side of the central corrals.
